Richland County Macroburst and Tornado Event July 29, 2011 National Weather Service Glasgow Storm Survey Summary

Results From Damage Survey

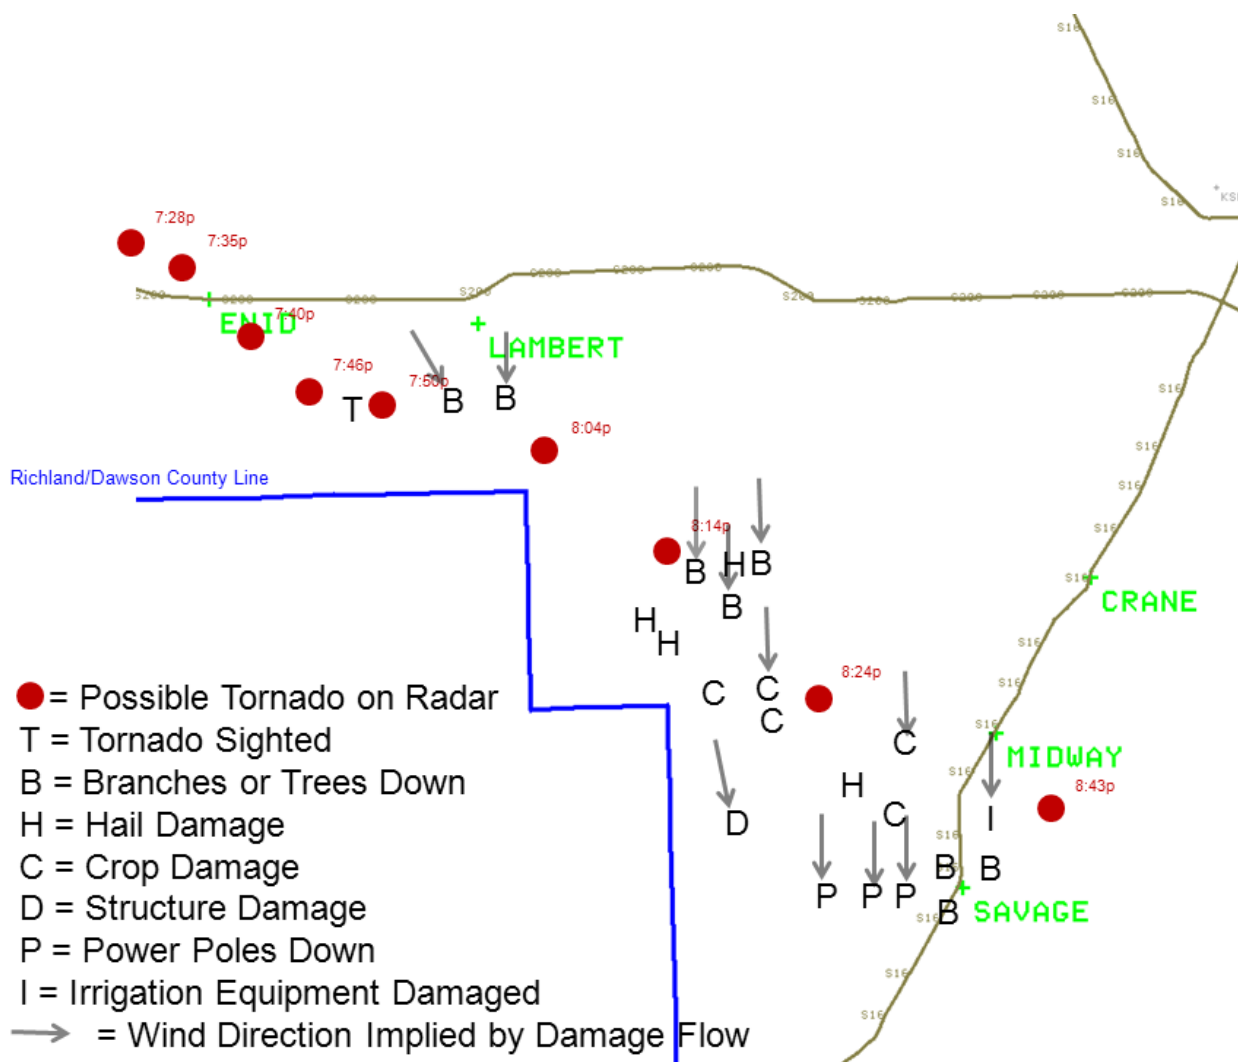
The NWS conducted a damage survey during the day on July 30. The area surveyed was from just northwest of Enid, MT to just south of Savage (Fig. 2). Figure 2 shows the location of damage surveyed, and the location of the tornado reported near Lambert. The red dots plotted in Fig. 2 are the location the KGGW radar indicated a possible tornado. Arrows show the direction debris moved or trees or crops fell.

Figure 2. Area with surveyed storm damage on 7/29/11 from Enid, MT to Savage. State highways 16 and 200 are included for reference as brown lines.

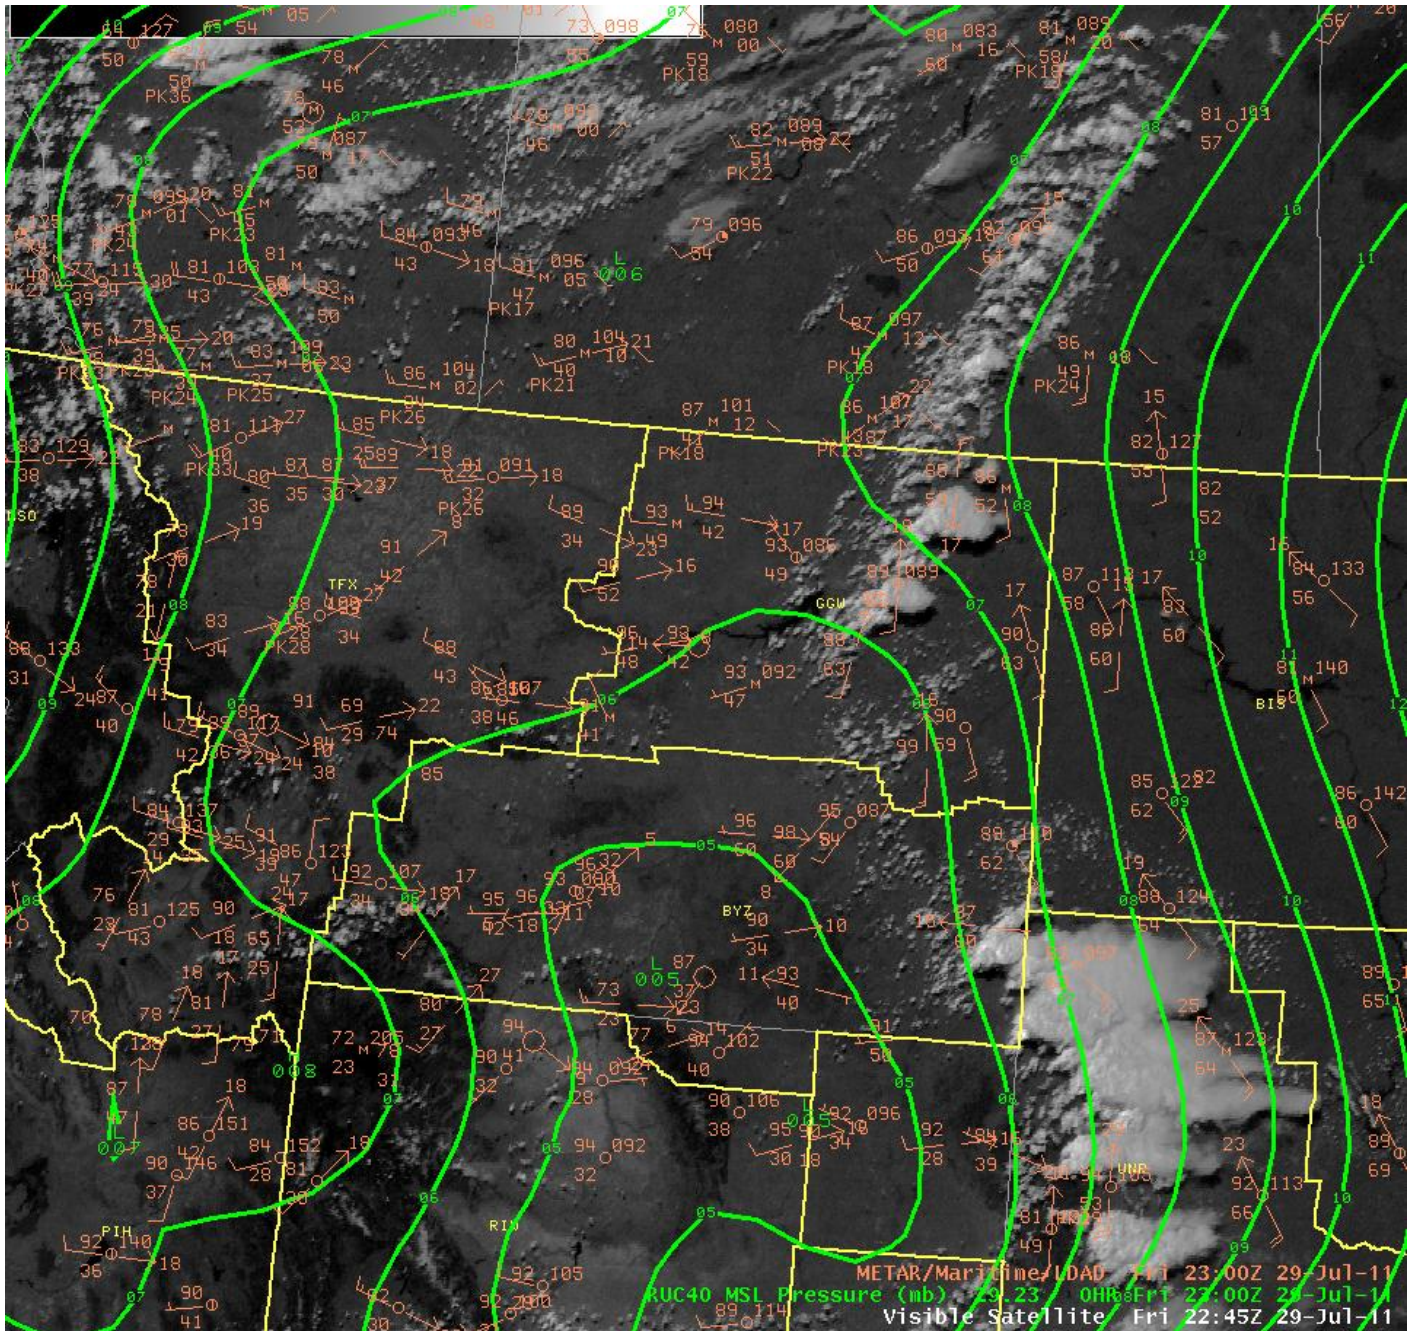
Figure 12 shows the situation at 5:00 pm, about the time of initiation. In this image, storms can be seen erupting along a line of cumulus located on the east edge of a surface trough of low pressure. The west-east dewpoint gradient is noteworthy. Dewpoints are in the 40s west of the line of cumulus and in the 60s east of it. There is also westerly surface flow west of line and south-southeasterly flow east of it. This line is similar to a dryline more commonly seen in the southern plains. Drylines are common locations for storm initiation.

Figure 12. Surface conditions and satellite image for 5:00 pm 7/29/11. Green contours are the RUC MSLP analysis, orange data and barbs (a full barb is 10 kts) are surface station reports (with temperature, dewpoint, MSLP, wind, and wind gust plotted), and the image is the visible satellite image.

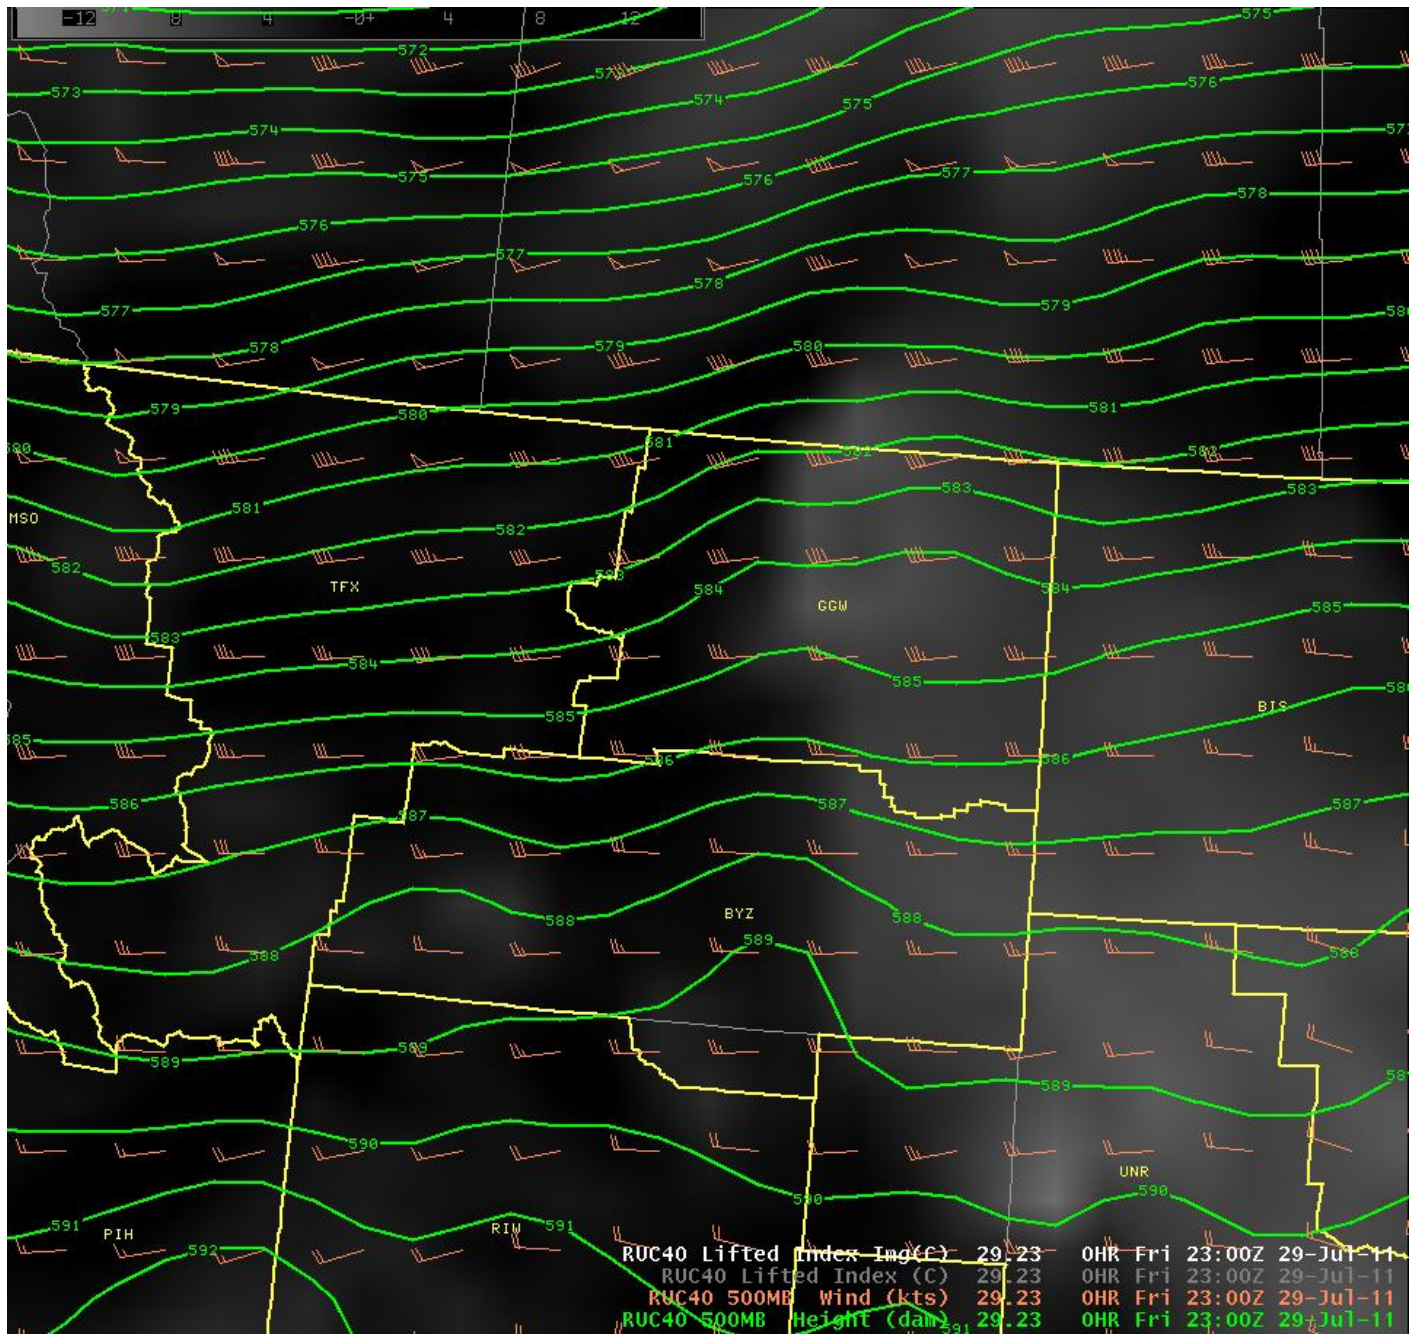
Figure 13 shows the 500mb heights and winds, along with the lifted index (LI) in shades of grey. This upper air pattern is not strongly forced, but some disturbances in the flow are apparent as wiggles in the 500mb height lines. The instability, as measured by the LI is negative (unstable) east of the dryline

at about -8 (moderately unstable). The 500mb winds of about 40 kts provide ample shear for severe storms when combined with southeasterly flow at the surface.

Figure 13. 500mb plot and lifted index (gray shades) for 5:00 pm 7/29/11. Full wind barbs are 10 kts.

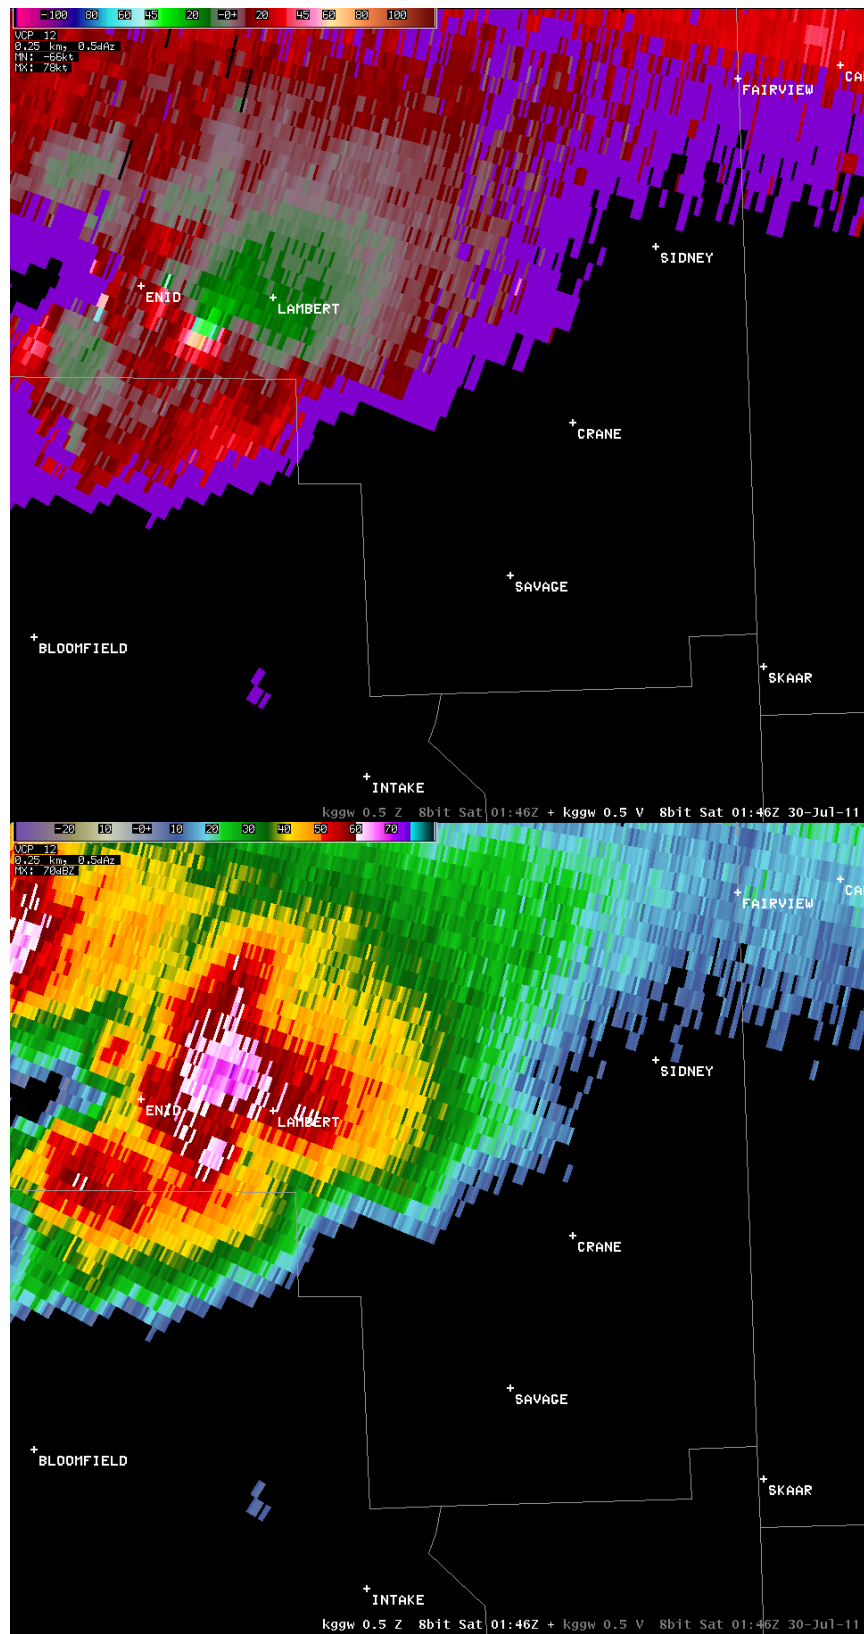
Figure 14 shows the KGGW radar data at the time of the strongest tornado indication. The top part of Fig. 14 shows the radial velocity. This shows a mesocyclone over the Enid to Lambert area with an embedded strong, local velocity couplet just west-southwest of Lambert. This velocity couplet is co-located with the tip of the hook in the reflectivity (bottom of Fig. 14), a typical place for a tornado to be. The velocity couplet also corresponds closely with the location of the spotted tornado 4 minutes later (Fig. 15). The radar is located in Glasgow, MT. At this distance from the radar, the radar beam is about 11 000 feet above the ground, so the velocity couplet is not proof of a tornado on the ground. That proof is provided by Fig. 15. Elevated velocity couplets; however, are the primary tool for radar detection of tornadoes, as they often precede tornado touchdown.

Figure 14. Radial velocity (top) and reflectivity (bottom) at 7:46 PM 7/29/11. KGGW radar.

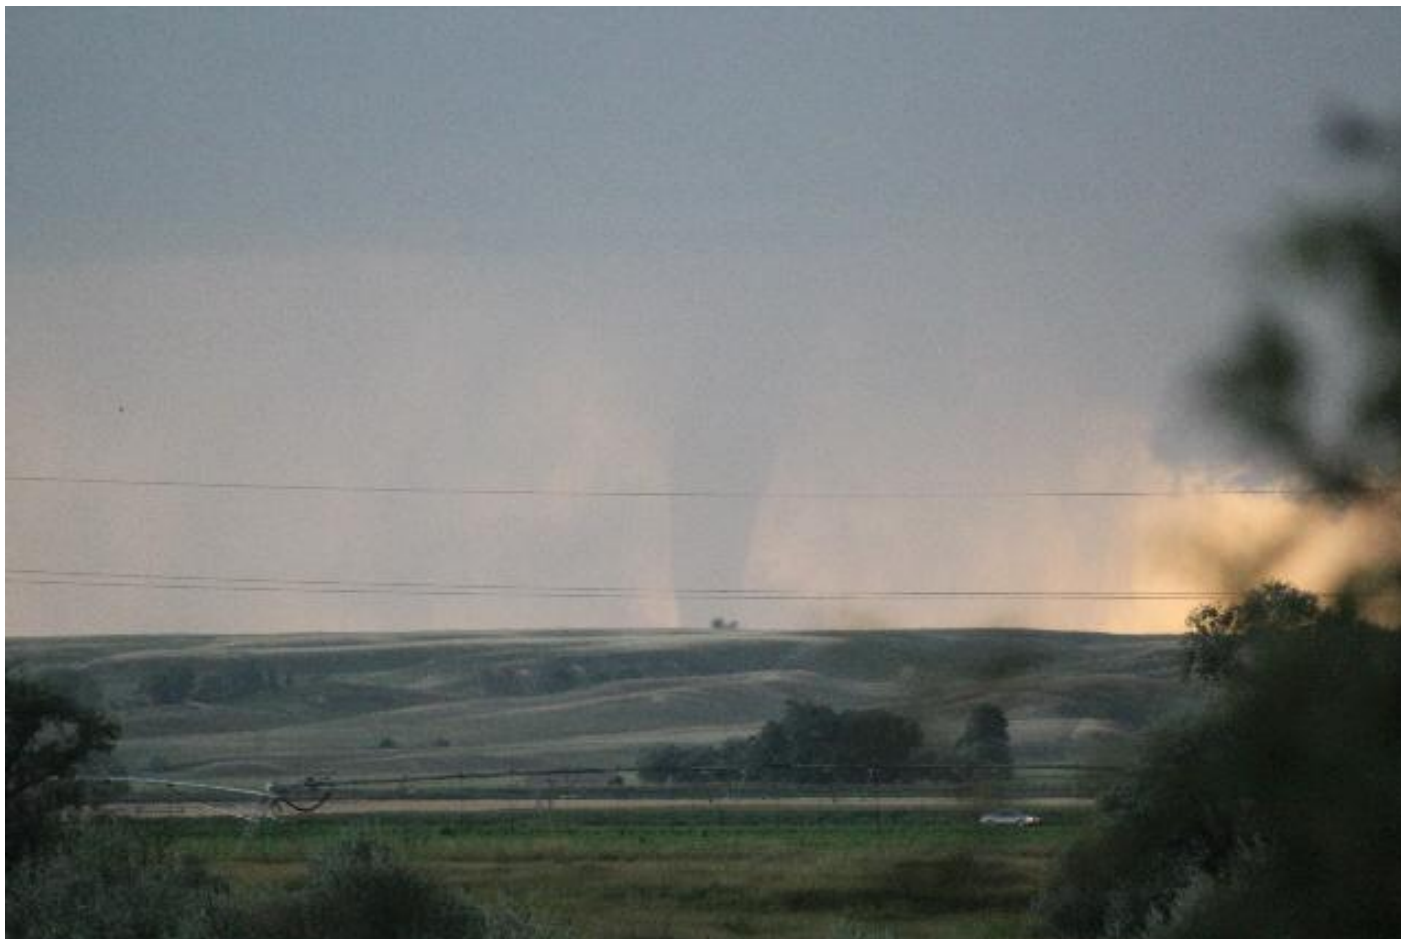
The survey team did not find any damage from a tornado at any location, though one was conclusively observed (see Fig. 15). This is not surprising as the time the tornado was observed, when combined with radar indications of a possible tornado, place the tornado in an empty area just southwest of Fox Lake near Lambert. A tornado in this location would not have left behind any damage for the survey team to catalog.

Figure 15. Photograph of tornado near Lambert taken at 7:50 pm 7/29/31 by Andrea Zelinsky.

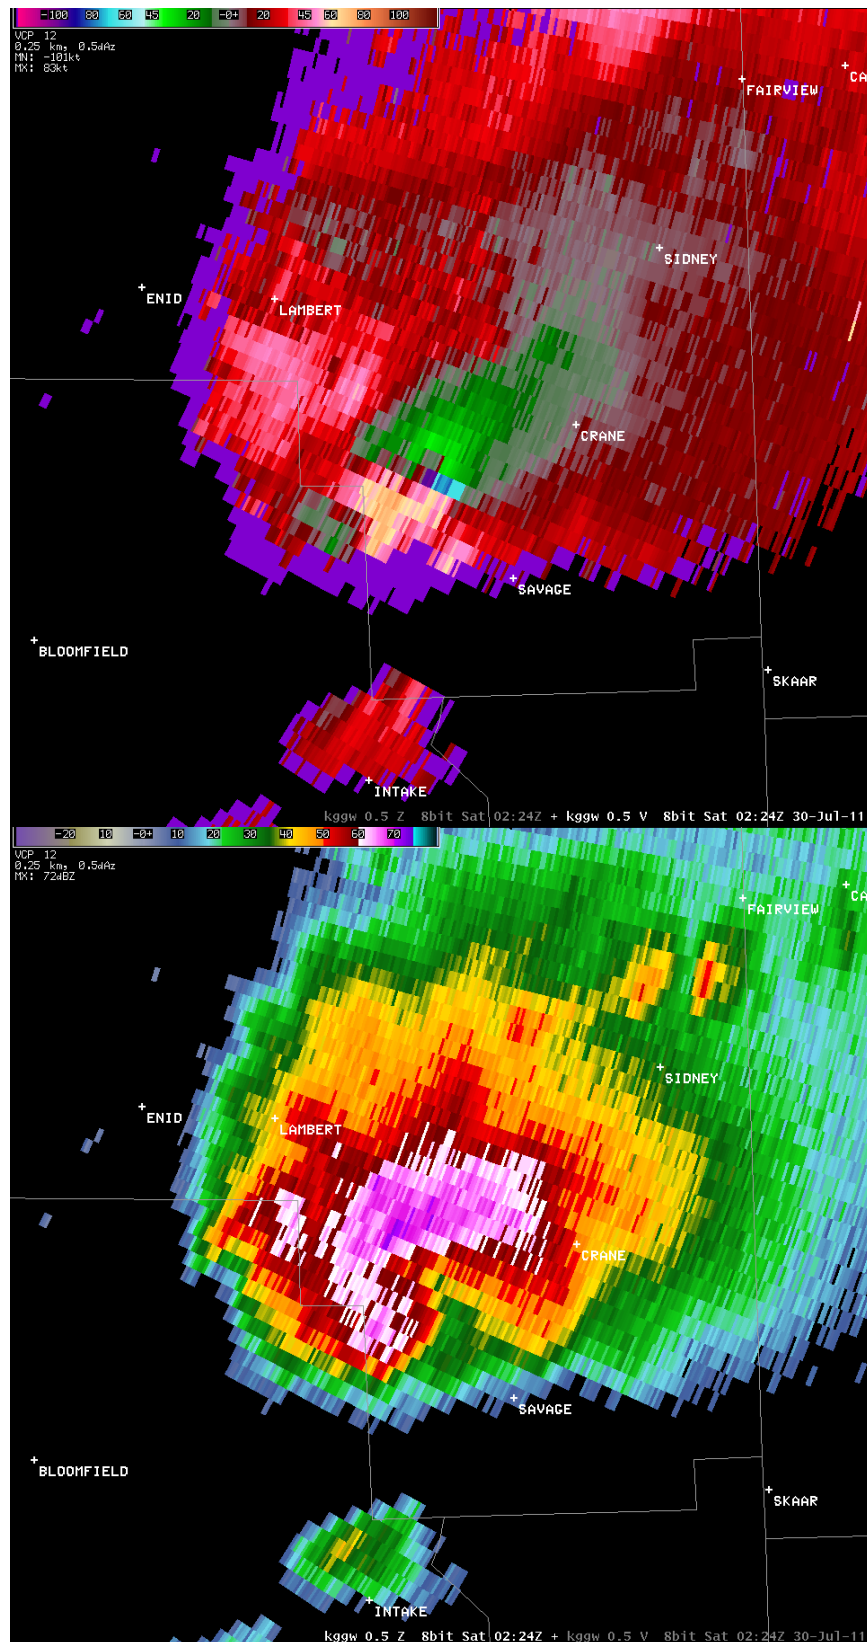
Figure 16 shows the radar data as the storm approached the town of Savage. At this time, the radial velocity (top of Fig. 16) shows a strong mesocyclone (with winds over 100mph measured northwest of Savage) and an embedded localized velocity couplet. However, in this case, no tornado was observed to touch down. The hook echo (Fig. 16 bottom) is very dense and corresponds with the area of 100+ mph northwest wind as seen by the radar aloft. Descending hail and rain in this area (known as the forward flank downdraft) accounts for the extreme straight line winds seen at the surface (the macroburst).

Figure 16. Radial velocity (top) and reflectivity (bottom) at 8:24 PM 7/29/11.
